# ARROWHEAD™

## PULLEY LAGGING

# Arrowhead™ Ceramic Pulley Lagging

# Arrowhead™ Drive & Non-Drive Rubber Pulley Lagging

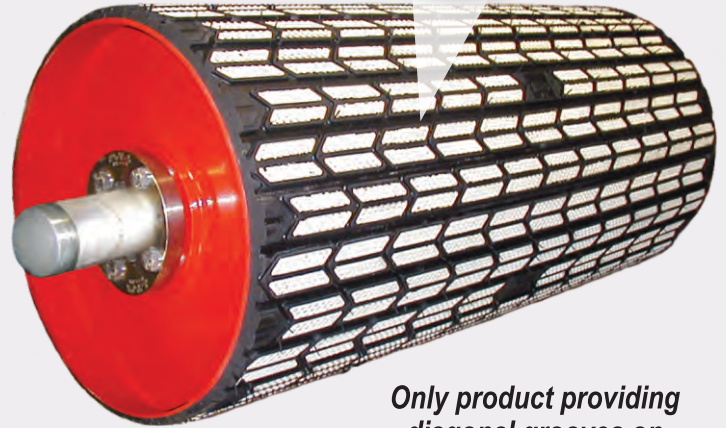
*Only product providing diagonal grooves on ceramic tile lagging for self-cleaning.*

*Designed to eliminate belt slippage and premature lagging wear.*

Arrowhead Ceramic Pulley Lagging provides the solution when conventional rubber lagging fails to correct a belt slippage problem and/or when rubber lagging wears prematurely. Our unique Arrowhead ceramic is designed for the highest drive factors unlike the conventional square tiles.

- **Increase Productivity** - by delivering increased traction between the belt and pulley. This allows for lower belt tension than with rubber lagging.
- **Improved Belt Tracking** - due to the Arrowhead patterns self-cleaning ability, which reduces material build-up and thereby eliminates the major source of misalignment.
- **Bonding Strength** - that is superior to others, due to 1/8" (3mm) of our neoprene compound vulcanized into bottom-side of the pulley lagging.
- **Extreme Durability** - in high feed rates and high conveying speeds and abrasive or highly wet or dry applications as seen in below ground and above ground mining.
- **Easy Installation** - can be done in place, on plant site, at your local distributor or at the pulley manufacturer. Each strip is 10" (250mm) wide x pulley face (see chart on back).
- **3 Year Warranty**

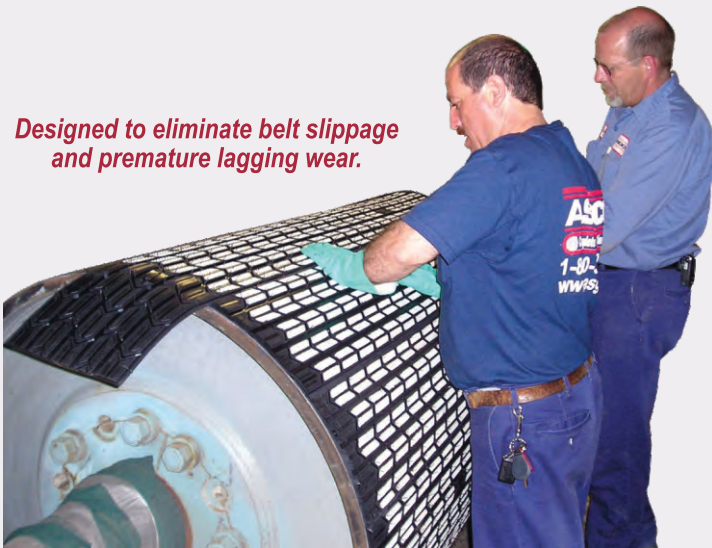
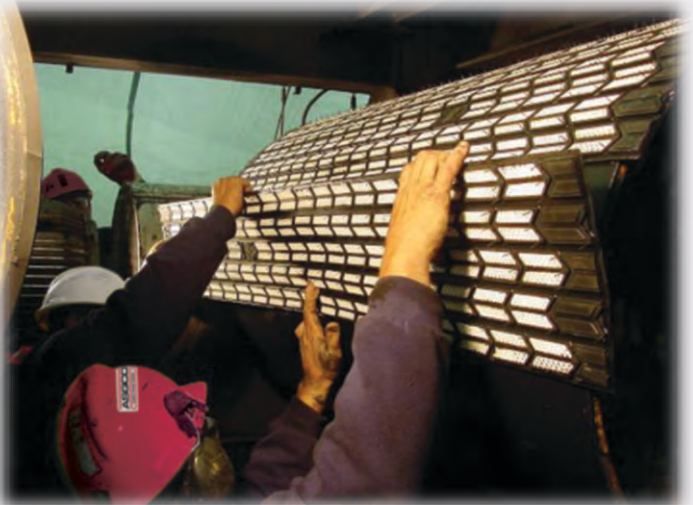
ISOMETRIC VIEW

## Design Features - Tiles

- High grade aluminum oxide ceramic
- Tile fully enclosed by rubber
- Rounded corners allow for better adhesion between the rubber and the tile

Arrowhead Ceramic	Arrowhead Ceramic
Total surface area of the ceramic as a percentage for the total?	50%
Width of each tile?	0.625"
Length of tile?	2"
Total thickness of ceramic?	0.32"
Percent of ceramic are raised?	27%
Height of ceramic nubs that extend above the ceramic tile?	.0625"
Diameter of ceramic nub?	0.16"
Number of nubs?	15

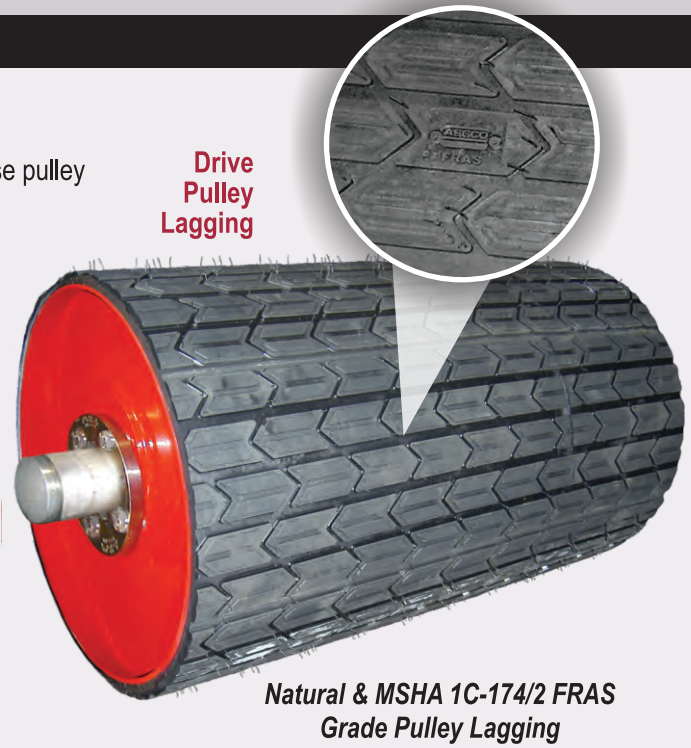
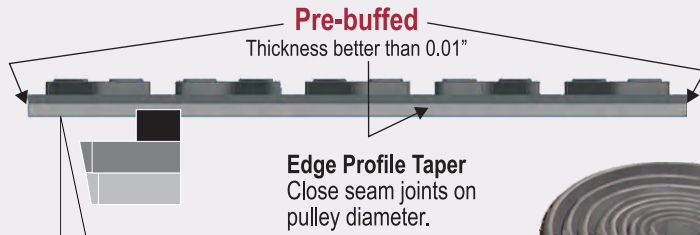
**Edge Profile Taper**  
Close seam joints on pulley diameter.

Non-Drive Pulley Lagging

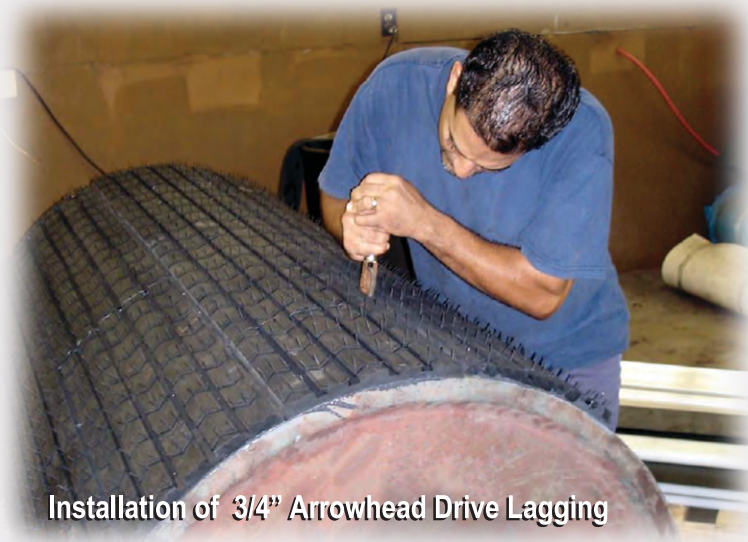
Installation of ¾" Arrowhead Drive Lagging

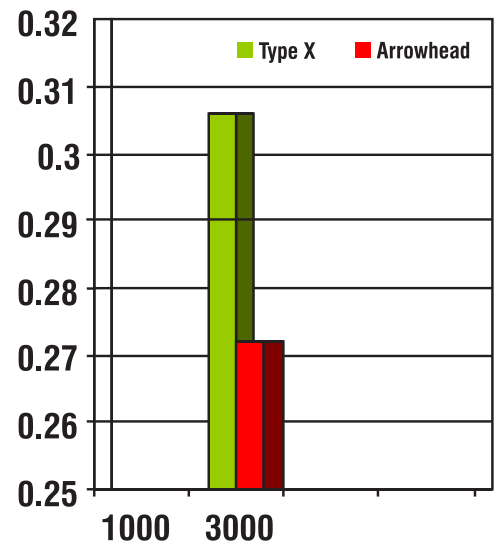
Total Amount of Material Loss

## Taber Abrasion Tests

• Taber Abrasion, ASTM D 3389-94 (99)  
 • H18 wheels, 1000 gram load per wheel, for 3000 cycles  
 • All tests were completed by Akron Rubber Development Laboratory, Inc. - [www.ardl.com](http://www.ardl.com)

*Arrowhead proved to be 12% more abrasion resistant than the leading competition.*
