Industry Updates and Solutions for Conveyor Material Handling Applications.

### Copper Mine Solves High Wear Areas with Armorite™

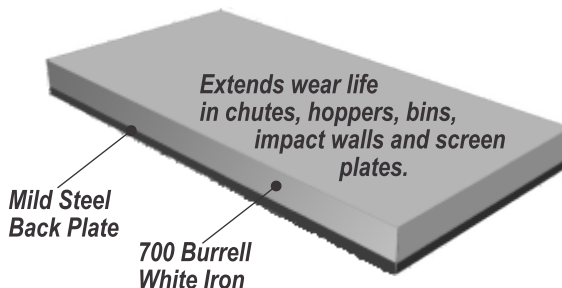
**ASGCO Armorite™ 700 Wear Plate**

ASGCO Armorite™ 700 is a combination of high chromium and molybdenum white iron metallurgically bonded to a mild steel plate. Armorite provides maximum protection in high water areas, with the mild steel backing cushioning the white iron enabling it to withstand impact. Armorite is easily weldable with minimal preparation.

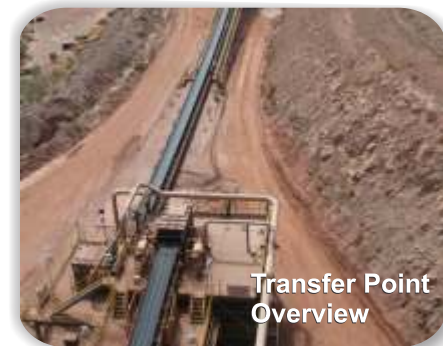
Transfer Point Overview

A copper mine was experiencing high wear in their "pant-leg" chute liners. A combination of abrasive material and high tonnages was the major factor why the mine was only about to get 4-5 weeks from 1" thick AR500 plates. The material being conveyed and transferred is; 2 1/2" minus crushed copper ore (105#/cuft @ 2.5% moisture) at a rate of 6800 TPH.

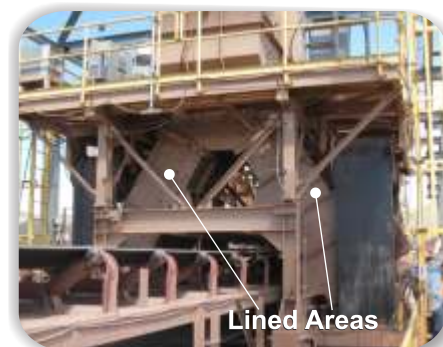
Lined Areas

Armorite 700 was selected for a 6 month test. After 12 months the Armorite 700 Liners were still in service with little signs of wear. The customer stated we "exceeded all expectations" and will be reviewing other high wear areas for ASGCO to solve.
