ASGCO® Safe-Guard™ Return Idler Cage Solves Safety Issues at this SE Coal Mine Surface Facility.

ASGCO® Safe-Guard™ Conveyor Return Idler Cage

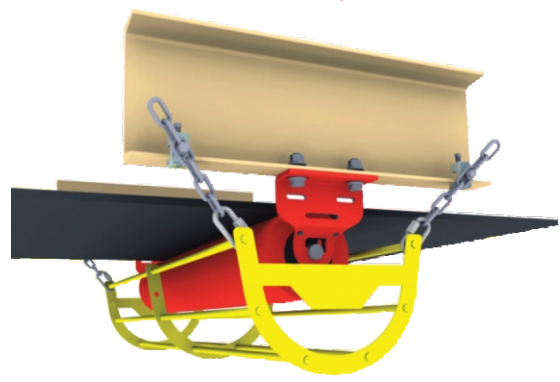
Catches the return idler if it falls!

- Prevents Idlers from Falling
- Easy to Install and Remove
- Complies with MSHA Title 30
- Meets OSHA Requirements
- Durable Powder Coated A-36 steel cage
- Open Slots prevent material build-up
- Available in Various Sizes to fit most belt conveyors
- No Welding Required.

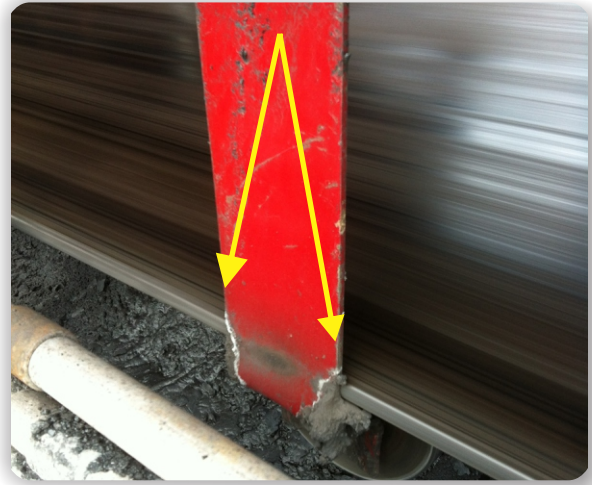
PROBLEM: Due to misalignment the belt is rubbing into the metal bracket. The bracket could give way causing the roller to fall.

This coal mine facility faced many challenges, as all bulk handling facilities do. Overcoming obstacles in improving the safety of their conveyor system was a top priority. These type of conveyor systems have a tendency to mis-track causing the belt to cut into the hanging metal brackets holding the return roller in place. If and when the bracket gives way the large return roller will be sent tumbling downward creating a dangerous safety hazard.

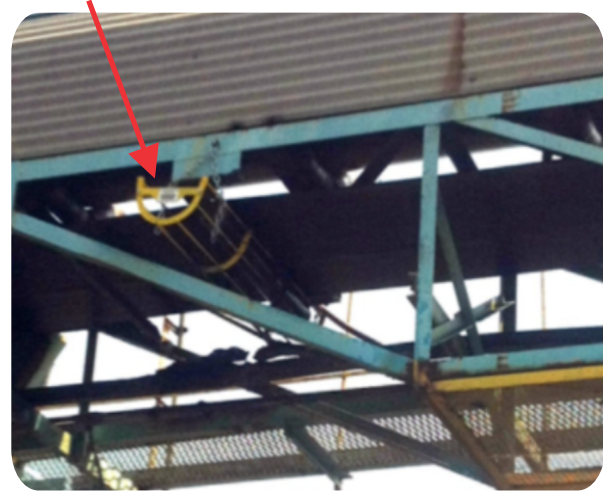
SOLUTION: ASGCO®'s Safe-Guard™ Conveyor Return Idler Cages were installed around the rollers to catch the roller if it falls and preventing injuries.

ASGCO® Safe-Guard™ Return Idler Cages were installed in the work areas and along the roadways to catch the return rollers if they fell. This brought the conveyors into compliance with MSHA title 30 regulations and helped the mine to reach it's safety compliance goal! The customer was very pleased with the success.
