## ASGCO® Conveyor Products Solve Fugitive Material Containment Problems at a Northwestern Coal Fired Power Plant.

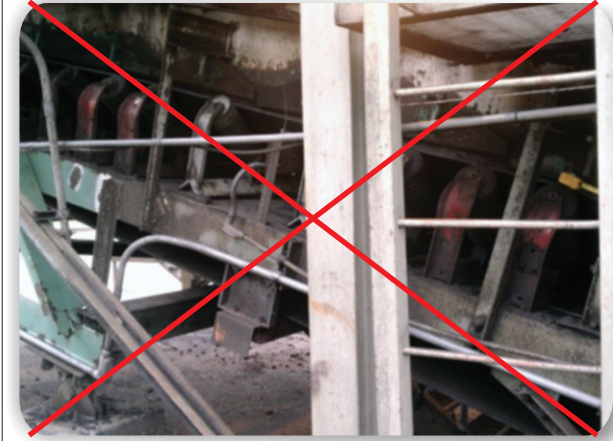
**PROBLEM:** Tremendous amounts of coal were escaping through the load zone area due to belt mis-tracking and inadequate support in the impact area of the load zone. Both situations resulted in excess spillage and airborne dust.

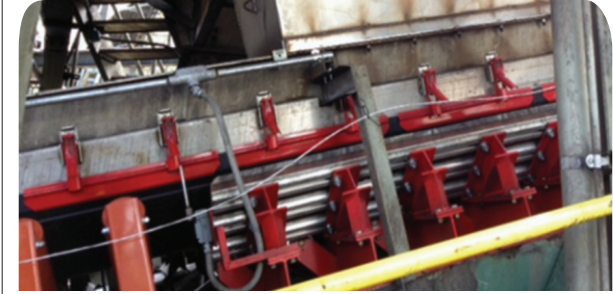
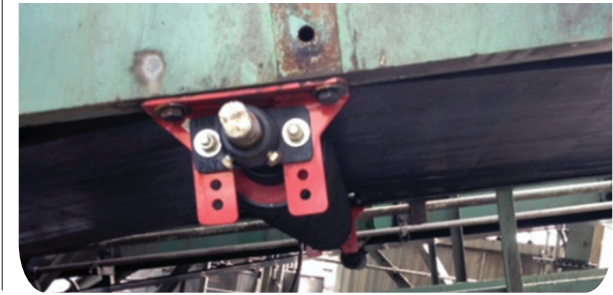
**SOLUTION:** Installation of ASGCO® Tru-Trainer® Flat Return Belt Tracking Idlers, Slide-N-Roll Impact Beds, plus Clamp-Mount Skirtboard Sealing Systems with Tri-Seal, reduced mis-tracking and housekeeping issues in the load zone.

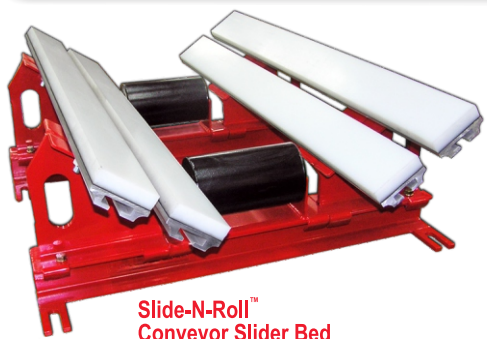
**Slide-N-Roll™ Conveyor Slider Bed**  
Provides a powerful load support while stopping dust and spillage in the conveyor load zone.

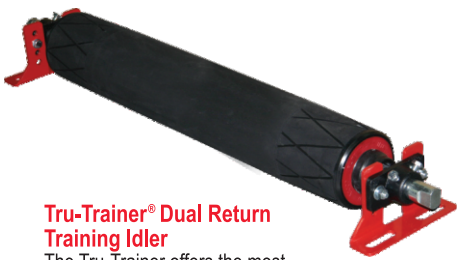
**Tru-Trainer® Dual Return Training Idler**  
The Tru-Trainer offers the most reliable and re-active belt tracking on the market.
