## ASGCO® Solves Chronic Spillage and Belt Tracking Problems at Large US Waste Recycling Center.

**Application:** 150' long, 60" wide incline belt carrying recycling materials and waste

**Objective:** Correct belt training issues related to premature belt failure & spillage

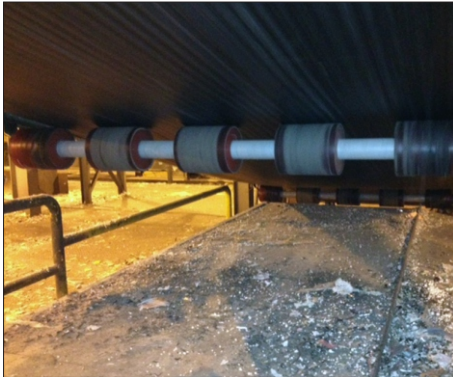
Dura-Sleeve™ Idler Installed

Upon completing a thorough conveyor inspection, ASGCO® technicians were able to identify several areas for improvement. Existing rubber disc return idlers were replaced with ASGCO® Dura-Sleeve™ Return idlers and an ASGCO® Tru-Trainer® Flat Return idler was strategically located between the head & tail pulley to insure the belt stays centered on the return idlers. This combination ensured that the belt would remain centered under the load zone and throughout its travel, eliminating spillage, premature belt wear & conveyor shutdown. ASGCO® Safe-Guard® Return Idler Guards were installed around each return idler to further ensure that maximum safety standards were met.

Once all of the Dura-Sleeve™ Urethane Return Idlers were replaced and centered, the ASGCO® Tru-Trainer® was installed, and fine-tuned for maximum performance. The belt no longer gets snagged or bounces across the rubber disc returns, and any minor belt mistracking is being corrected by the Tru-Trainer®. Weather, wind and material loading were all factors in resolving these issues. The belt operates much more efficiently, spillage has been virtually eliminated, and the lifespan of the belt will increase dramatically. This plant now experiences much less downtime, requires far less clean up and promotes a much safer working environment for its employees.

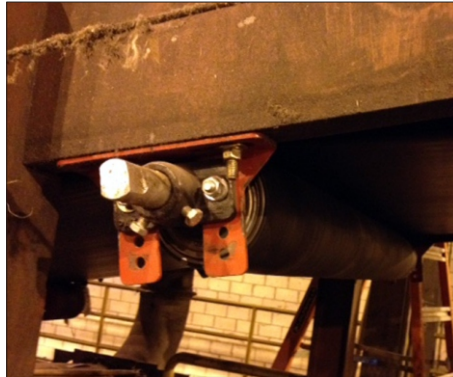
Tru-Trainer® Flat Return Idler Installed

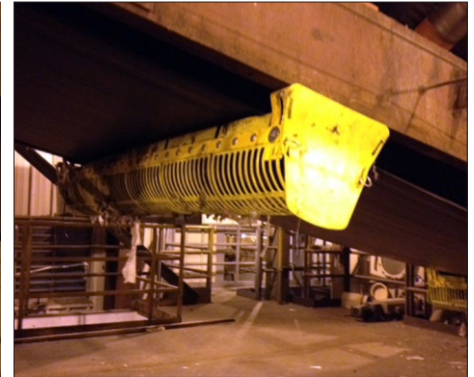
Safe-Guard® Return Idler Guard Installed
