ASGCO® Fourthane® Provides Solution for Fast Repair of Conveyor Belt Covers

Industry	Copper Mine in the Southwest, United States
Application	Solution for time and money saving repair costs of rubber coatings and conveyor belt covers
Product	Fourthane® Repair System
Objective	Patch wear damage and restore belt cover on feeder belts

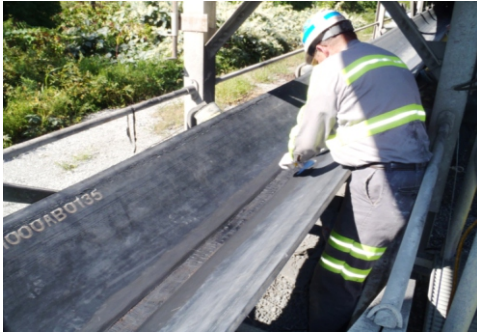
BEFORE

Grinding/Cleaning old rubber out of damaged conveyor belt.

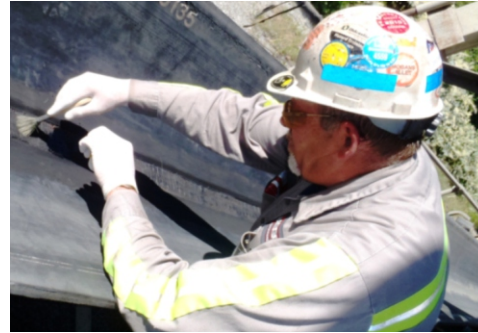
Applying cleaner and primer.

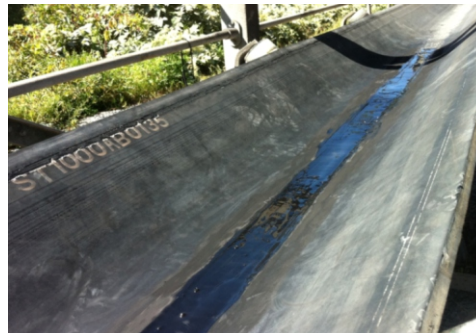
AFTER

Finished. Longitudinal groove repaired.

Allowing one hour after repairs have been made, Fourthane® has cured, achieving the physical properties similar to that of the conveyor belts rubber cover and allowing operation of the equipment to resume. This easy repair system accomplished a cost effective way to repair, instead of replace, damaged belt covers while minimizing down time for a money saving solution.
