Armorite Wear Liners Drastically Reduce Maintenance Costs at Copper Mine

Application Copper Ore Tripper Tertiary Crusher Feed System
Material 2 ½" minus Secondary Crushed Copper Ore
Material Spec 105#/cuft @ 2.5% moisture
Capacity 6800 TPH

Liner Installation Location Tripper Car "Pant Leg" Chutes

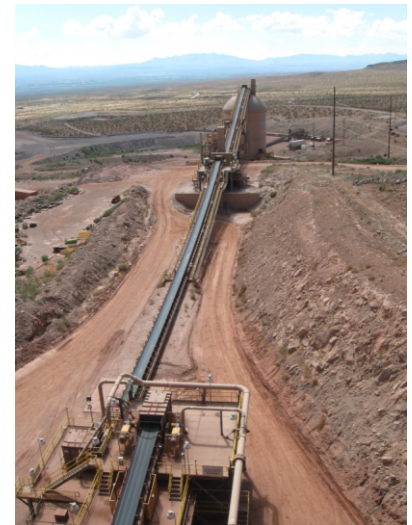
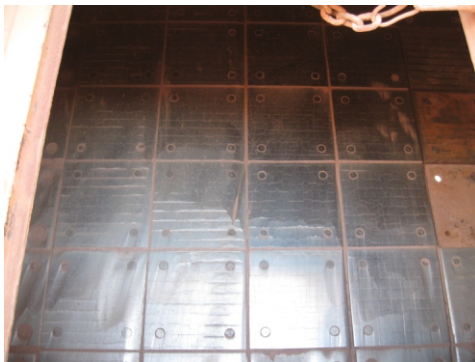
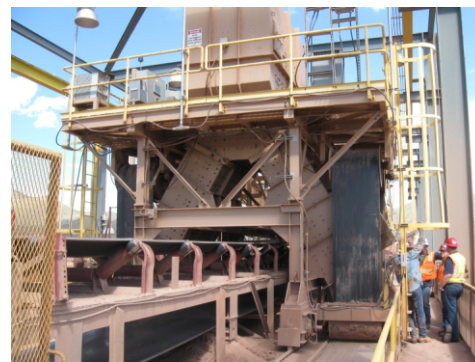
Note: The original Armorite "test" liners were in service for approximately 16 months prior to being replaced, which equates to a 16+ times service life over the AR500 cast liner product.

After 12 months (one year) the Armorite 700 Liners were still in service. The customer was convinced they had finally found a product that would "**out perform**" anything they had previously tried. We "**exceeded**" all expectations and were asked to come in to measure all of the liners to be used in this Tripper Car "Pant Leg" Chute.
