OCTOBER 2016

## ASGCO® One Sided Slide-ler™ Solves Load Zone Maintenance Problem at Coal Handling Facility.

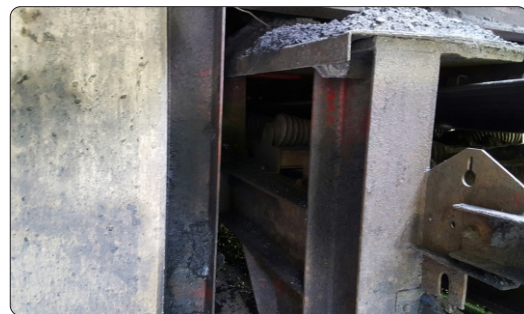
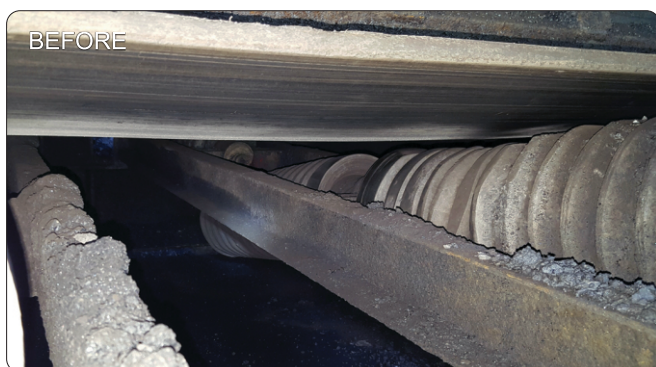
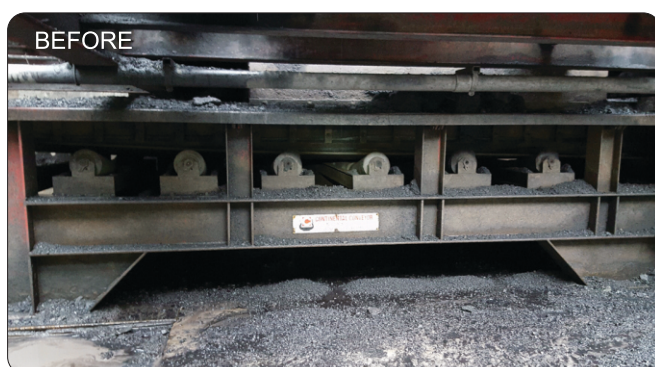
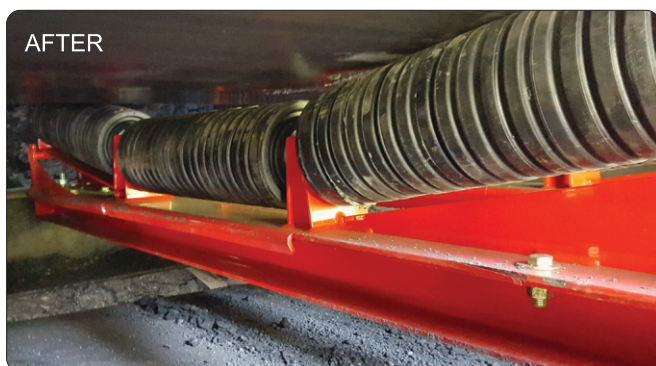
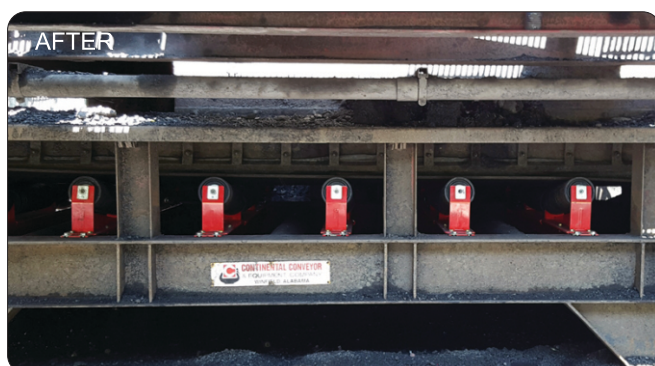
The challenge was to be able to remove and to replace the impact rollers in this tail section with access limited to only one-side, while providing an easier alternative to servicing them in the future. Many of the existing impact rollers had already failed. Some were stuck, worn flat, shafts broken, and some were even missing. These impact rollers were at a 10° trough, like many of the tailpiece style sections, where changing one of the impact beds was very difficult. The 'off' side of the transfer was blocked by a concrete footing or pillar. Any servicing that needed to be done on this side was cumbersome and in some cases depending on the problem, impossible.

The suggested solution was to remove the old impact rollers that were already deteriorated and to install One Sided Slide-lers™. The One Sided Slide-ler™ is designed to be maintained from one side of the conveyor, allowing you to replace the rolls with minimal downtime. This is the ideal system when access is only on one side of the conveyor or where a conveyor is located against the wall or high in the air with the catwalk on one side.

The installation was problem free, even though the clearance was at a minimum. Due to the modular design they are now able to change out the rolls without having to remove adjacent idler frames. The 'off' side, middle and near impact roller can now be changed by removing four easy to reach bolts. PROBLEM SOLVED! The customer is very pleased with the results and the conveyor is back in working order, no more concerns about failing impact idlers!
