## **ASGCO® - Safe-Guard™ Return Idler Cage Solves Safety Issues**

<b>Industry</b>	Southeastern Coal Mine Surface Facility
<b>Application:</b>	48" Conveyor system
<b>Product:</b>	ASGCO® Safe-Guard™ Conveyor Return Idler Cage
<b>Objective:</b>	Address safety concerns for unsuspecting employees, as well as, visitors in close proximity to the overland conveyors. The measures were also put in place to bring the conveyors in compliance with MSHA and OSHA standards in regards of proper guarding.

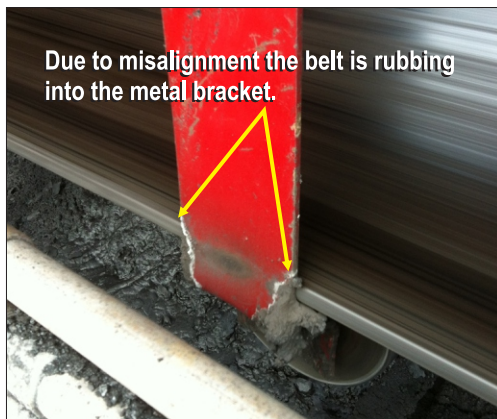
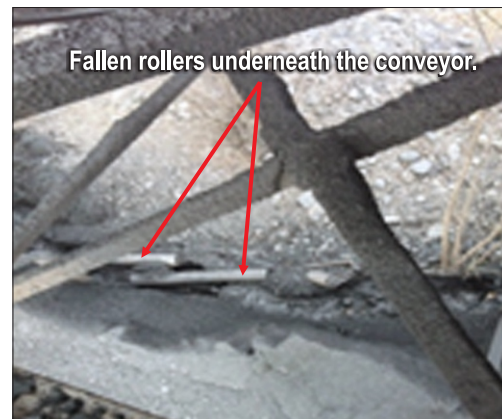
This coal mine facility faced many challenges, as all bulk handling facilities do. Overcoming obstacles in improving the safety of their conveyor system was a top priority. These type of conveyor systems have a tendency to mis-track causing the belt to cut into the hanging metal brackets holding the return roller in place. If and when the bracket gives way the large return roller will be sent tumbling downward creating a dangerous safety hazard.

After a thorough inspection of the conveyor it was pointed out that in addition to resolving the belt mis-tracking issue there needed to be further changes made to ensure safety in the workplace and to comply with OSHA and MSHA requirements. It was recommended that they install ASGCO® Safe-Guard™ Return Idler Cages to protect the return rollers and objects from falling, preventing injuries to workers and equipment.

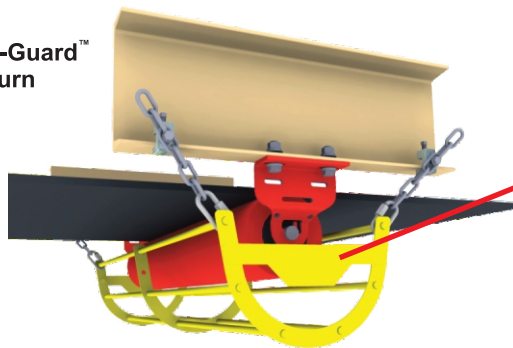
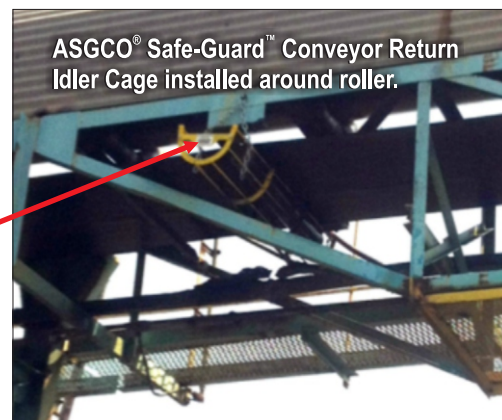
**ASGCO® Safe-Guard™  
Conveyor Return  
Idler Cage**

ASGCO® Safe-Guard™ Return Idler Cages were installed in the work areas and along the roadways to catch the return rollers if they fell. This brought the conveyors into compliance with MSHA title 30 regulations and helped the mine to reach it's safety compliance goal! The customer was very pleased with the success.
