ASGCO® APPLICATION CASE STUDY SOLUTIONS / RESULTS

ASGCO® Solves Southwest Coal Fired Power Plant Rail Car Dump Transfer Point Problems

Industry: Coal Fired Power Plant

Application: Transfer chute under railcar dump

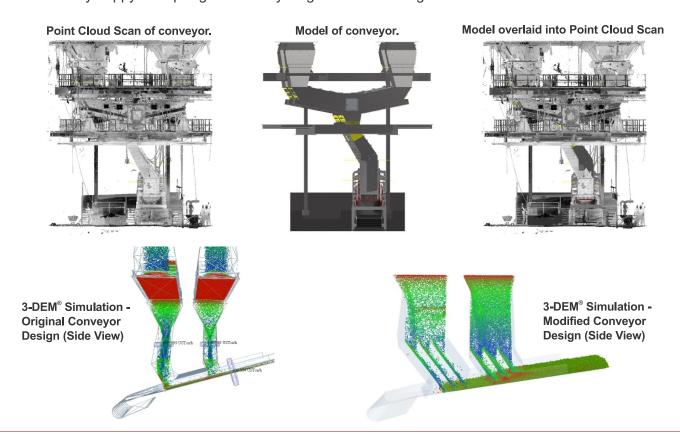
After the material was dumped it went through a series of grizzly bars, then through all of the chute work below on 4 different levels. With the existing design the material was off-center loading which was pushing the belt to one side and causing the material to spill and wear the belt unevenly. They also had internal deflector plates installed at the bottom of the chutes to try to guide the material, but it wasn't working and they were wearing out. The chute needed to be re-designed to center the material flow onto the belt.

Part of the project was to replace the grizzly bars, along with four of the chutes, exactly as they were originally designed. The lower portions had to be re-designed to solve the off-center loading issue. ASGCO® engineers performed an on-site Point Cloud Laser Scanning survey to provide accurate measurements of the existing transfers. Then a 3-DEM® simulation was developed to validate that the flow would fall onto the center of the belt through the new chutes.

Since it was coal and various sized material, the simulation process took several weeks to complete. We scanned it, designed it, detailed it, fabricated the chutes and delivered it all before the shutdown deadline. The project was installed with no issues and the material flow is center loading onto the belt. The customer is extremely happy. No spillage and everything is center loading.
