ASGCO®- Wash Box System

Industry	PRB Coal Burning Power Plant
Application	Installed as a secondary belt cleaner for a conveyor running through a tunnel, making it difficult for cleaning the underneath of the conveyor
Product	ASGCO®- Wash Box System
Objective	Prevent carryback and keep dust to a minimum

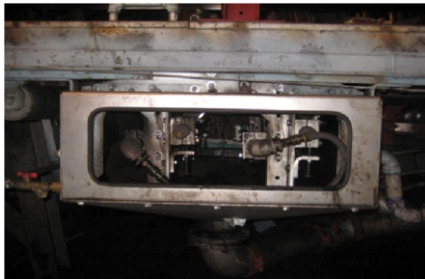
Wash Box Installed

After surveying the conveyor with the plant engineer we decided to install an ASGCO® Wash Box system right past the head snub pulley. This location allows us to clean the belt right after the coal leaves the chute area. As the belt enters the wash box it first comes in contact with the first spray bar that sprays water onto the belt (the spray helps loosen the coal away from the belt) then the first ASGCO® Razor-Back™ with tungsten carbon blades scrapes the belt. The belt then sees a second spray bar and then another ASGCO® Razor-Back™ system, as the belt leaves the wash box there is a rubber squeegee that help take off any leftover water.

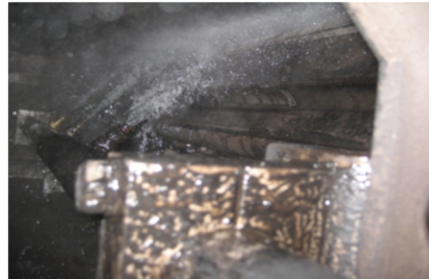
Water Spray Bar Cleaning the Belt

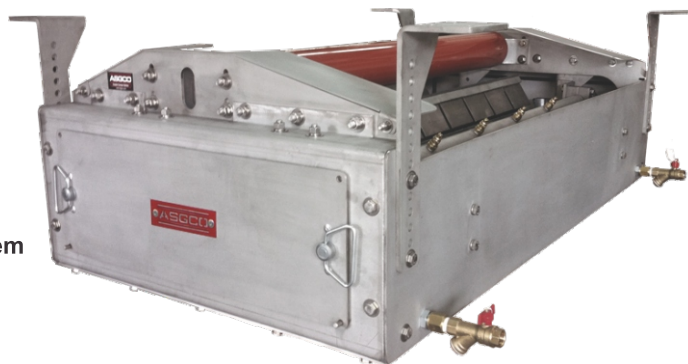
ASGCO® Wash Box System
