Aaron Gibbs, ASGCO, USA, discusses improvements and maintenance to belt conveyors that can help reduce total cost of ownership and improve safety.

SAFETY BY DESIGN

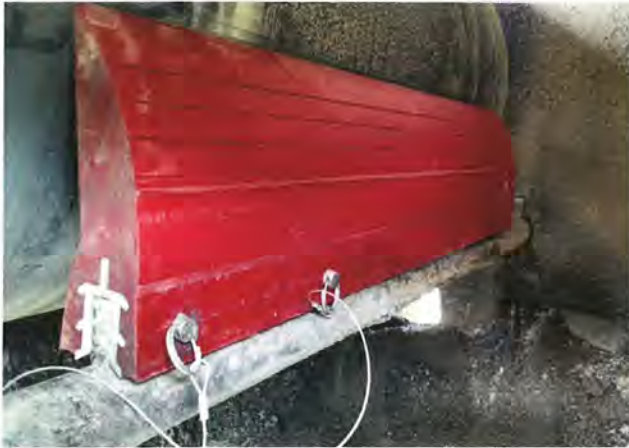
Figure 1. A Skalper with E-Z Torque® tensioner installed on the head pulley for maximum belt cleaning performance.

environment, the standard stainless steel construction of the ASGCO Skalper® series belt cleaners provides longer life for the support and tensioning mechanisms. Not only does the stainless steel construction eliminate the rust issue, but they are also available with external serviceability capabilities to eliminate confined space entry issues and reduce routine maintenance time required for inspection and service. This example of 'Safety by Design' lowers the total cost of ownership while improving belt cleaner performance, as shown in Figure 1 (which was taken at a major North American port facility).

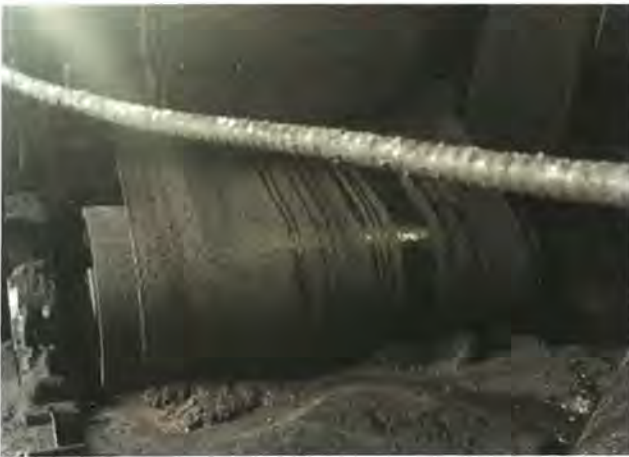
Figure 2. The tail pulley is buried in material.

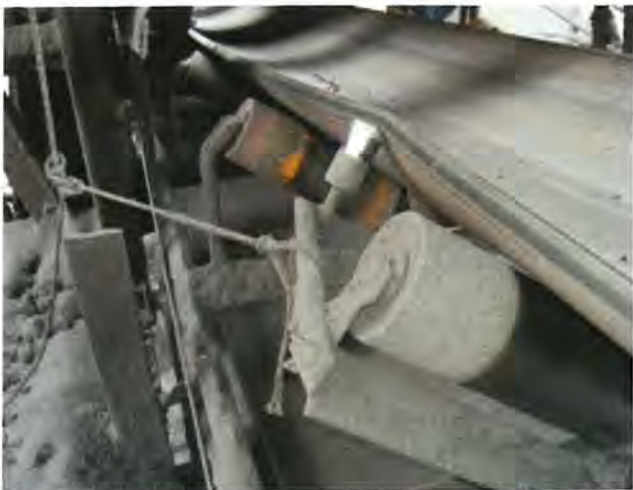
Figure 3. Ordinary training idler tied off with a rope causing material build up on the support frame work and belt edge damage from friction and pressure.
