ISSUE NO.188 FEBRUARY 2016

Coal handling improvements to belt conveyors

USING ASGCO®'S PRINCIPLE OF 'SAFETY BY DESIGN' TO ACHIEVE LOWER TOTAL COST OF OWNERSHIP

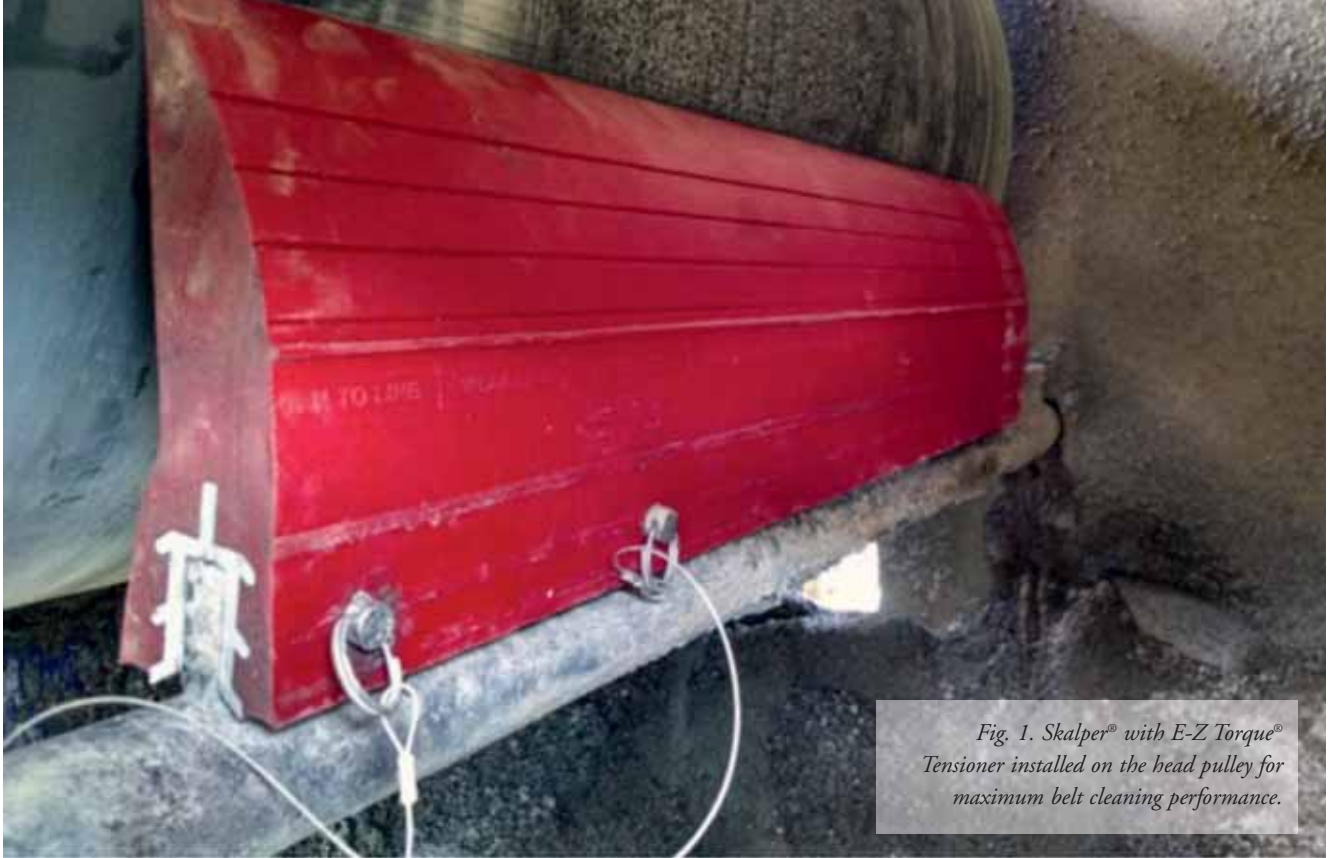
Fig. 1. Skalper® with E-Z Torque® Tensioner installed on the head pulley for maximum belt cleaning performance.

environment, the standard stainless steel construction of the ASGCO® Skalper® series belt cleaners provides longer life for the support and tensioning mechanisms. Not only does the stainless steel construction eliminate the rust issue, but they are also available with external serviceability capabilities to eliminate confined space entry issues and reduce routine maintenance time required for inspection and service. This example of 'Safety by Design' lowers the total cost of ownership while improving belt cleaner performance as can be seen in Figure 1 on p84 taken at a major North American Port facility.

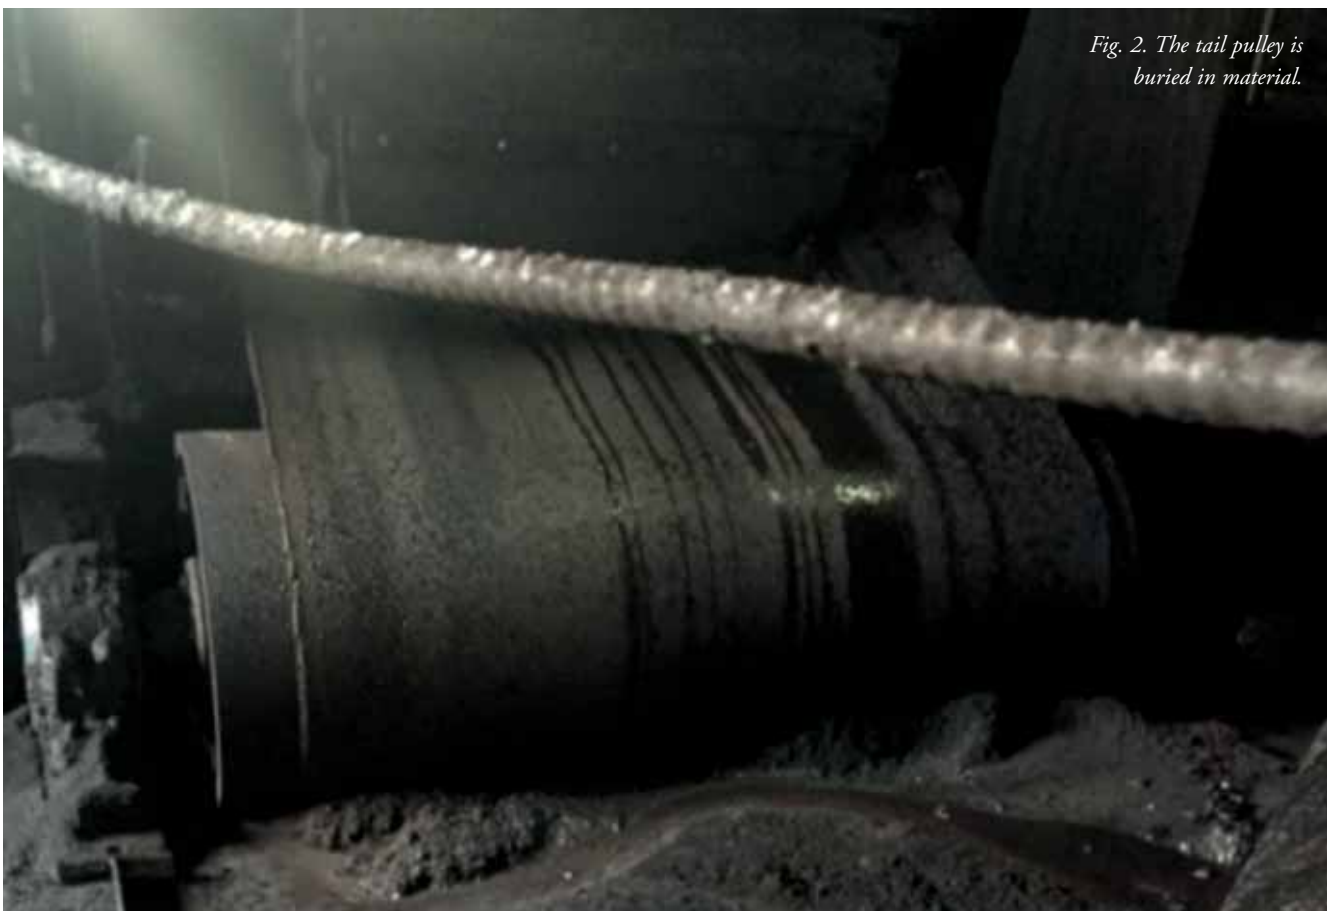
Fig. 2. The tail pulley is buried in material.

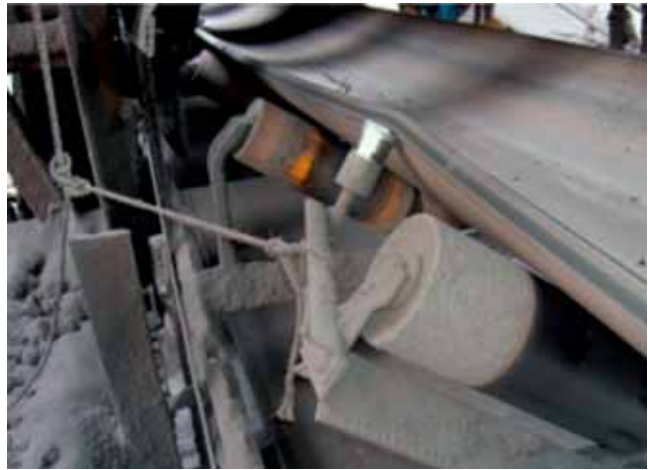
Fig. 3. Ordinary training idler tied off with a rope causing material build up on the support frame work and belt edge damage from friction and pressure.

employed at many port facilities and terminals around the world. These training devices are quick acting, very effective and have no roller guides or 'ears' that can damage the conveyor belt, which is by far the most expensive component on a bulk handling conveyor system. A device in use which shortens the life of the conveyor belt carries an economic penalty for the owner of the system. There is no support mechanism required under the tracking device for material to build up on as is common with all other styles of training idlers available. The safety by design with the ASGCO® Tru-Trainer® relies on a self-activating internal pivot that does not need side guide rollers to influence the belt travel. The elimination of areas where fugitive material can build up resolves a regulatory compliance issue. The Tru-Trainer® belt tracking devices are frequently installed prior to the load zone on the return side of the belt to ensure that the belt is centred under the load being discharged onto the belt at the transfer point. They can also be used on the carrying side with no belt edge contact. As anyone who has worked around bulk handling conveyors can attest, it is not uncommon to see ordinary training idlers tied off with a rope to ensure that the belt receives maximum influence. (See Figure 3, right). This is a tremendous safety hazard for employees working near the conveyor. This old belt training technology can frequently result in belt edge damage from friction and pressure as well as delamination of the belt carcass which is the tension member responsible for carrying the load. Another fugitive material issue in dry bulk coal handling facilities is the fact that some coals can be plagued by combustible dust issues. Heat from friction can be a source of concern. The Tru-Trainer® has no belt edge contact to create
