SIGNED, SEALED, DELIVERED

Joe Sander, ASGCO®, USA, details the company's ongoing commitment to providing solutions to operators with conveyor belt problems.

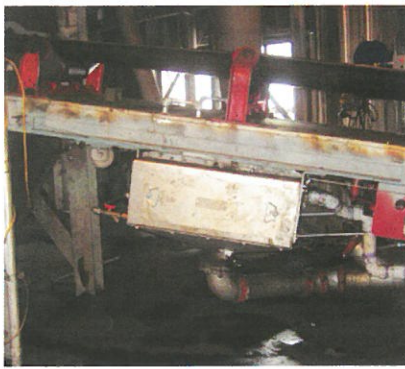
Wash Box secondary belt cleaning system: fully-enclosed Wash Box system provides excellent belt cleaning, while containing the wash waste fluid.

Solution: The ASGCO Wash Box was installed as a secondary conveyor belt cleaner, designed to work on the return side of the conveyor belt.

create the highest level of dust control and belt cleaning with its patented Wash Box™ system. This self-contained secondary belt cleaning system is positioned after the head pulley to loosen stubborn coal residue from the belt with powerful water jets. The material is then scraped from the belt with a series of tungsten Razor-Back®

blades and then rinsed one more time with powerful water jets. Dust is released from the bulk material residue before it has a chance to leave the belt and become airborne or fall off the return side and contaminate other components.

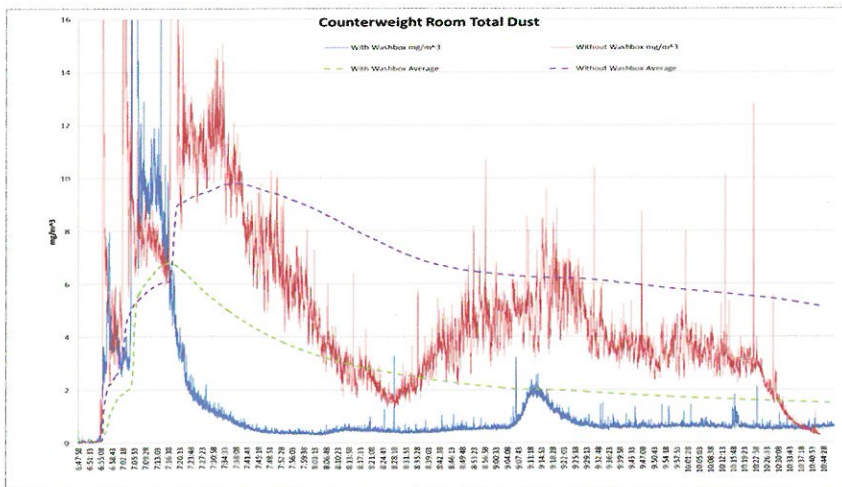
Air quality tests showed a reduction of dust levels of 60% or greater. Dust levels without the Wash Box averaged 6 mg/m³ and dust levels with the Wash Box average less than 2 mg/m³.

Air quality tests have proven that the airborne dust levels in this area of the plant showed a reduction of 60% or greater. Operators that were originally hesitant to use the Wash Box system, now insist that it runs every day. Dust levels without the Wash Box averaged 6 mg/m³, while dust levels with the Wash Box averaged less than 2 mg/m³.

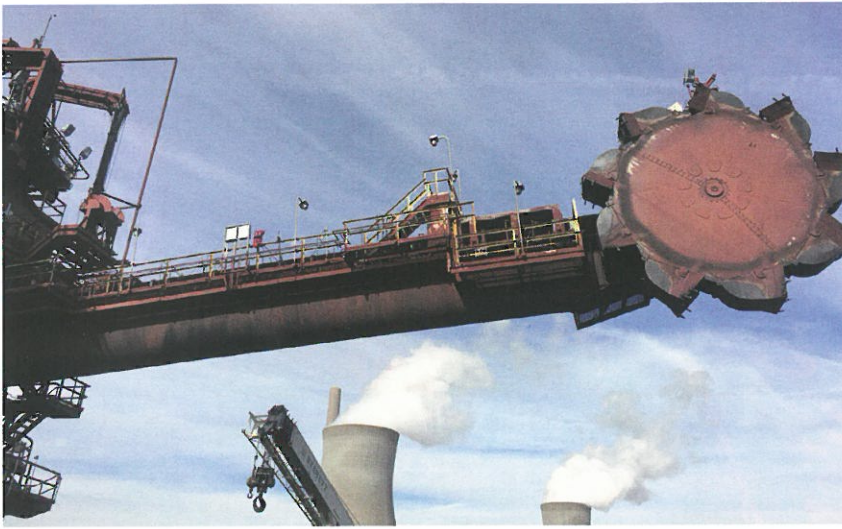
Stacker reclaimer reversing conveyor 60 in. wide steel cable belt.

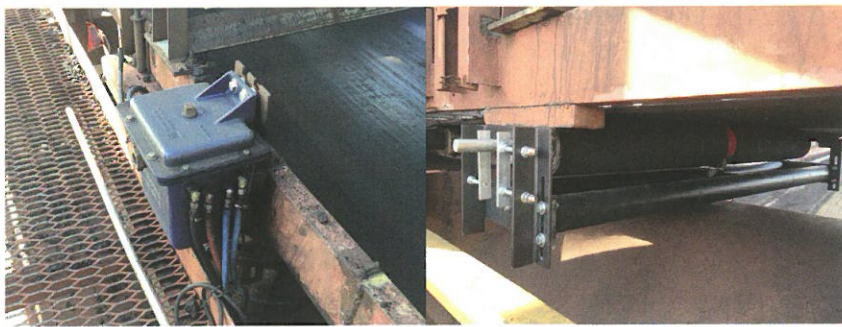
Before (left): This conveyor had a failing hydraulic three return idler belt training system that would not properly keep the conveyor belt in line. After (right): ASGCO engineered Tru-Trainer low-profile dual return system with a height of only 11.8 in., installed to continually re-centre the belt.

For many years, this conveyor had a hydraulic three return idler belt training system that would not properly keep the conveyor belt in line. The plant was constantly facing downtime to repair the hydraulic system. Even when operational, the belt would veer off-centre and come into contact with the structural supports, leading to critical damage to the belt and costly material spillage. The problem persisted upon installation of a new belt and, within 12 months, it needed to be completely replaced a second time.

To further complicate this application, the conveyor also has less than 13 in. of height to mount any type of return training roller. Options for eliminating the tracking problem were extremely limited by these space restrictions.

After ASGCO's technicians performed a complete survey of the conveyor system, the problem issues were identified. It was recommended that an ASGCO Tru-Trainer dual return idler was to be installed on the return side of the conveyor, 30 ft before the tail pulley. This position would allow the belt to run straight around the tail pulley and also be centred on the conveyor in the load point, reducing spillage and costly material loss. In addition, the rubber disk return idlers were replaced with Tru-Trainer flat return idlers, eliminating resistance to centring.

After installing two low-profile dual return Tru-Trainers about 20 ft from each stationary pulley, the belt is maintaining centre alignment and the
