# WORLD COAL®

APRIL 2016 - VOLUME 25 NUMBER 4

# SAFETY FIRST

**ASGCO®, USA, introduces improvements to belt conveyors that use the company's principal of safety by design to achieve lower total cost ownership.**

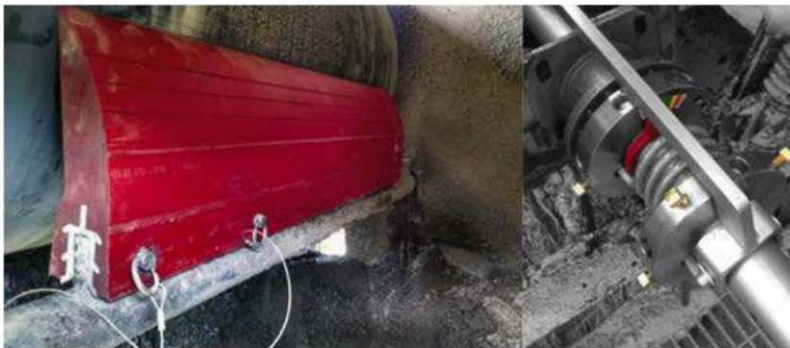
Figure 1. Skalper® with E-Z Torque® tensioner installed on the head pulley with external blade wear indicator and external serviceability capabilities.

A common problem is fugitive material. Fugitive material can come from many sources in a belt conveyor operation. One source of fugitive material is material being carried back on the return side of the conveyor belt. Belt cleaners are employed at the head pulley location in primary, secondary and also tertiary locations. In order to achieve maximum performance with minimal maintenance, the standard stainless steel construction of the ASGCO Skalper® series belt cleaners provides longer life for the support and tensioning mechanisms. Not only does the stainless steel E-Z Torque® tensioner allow for automatic adjusting of the blade tension, it also

comes with an external wear indicator. As a result, there is no longer a need to look inside the head chute to check for blade wear, thus eliminating a potential safety concern. They are also available with external serviceability capabilities to eliminate confined space entry issues and reduce routine maintenance time required for inspection and service. This example of safety by design lowers the total cost of ownership, while improving belt cleaner performance (Figure 1).

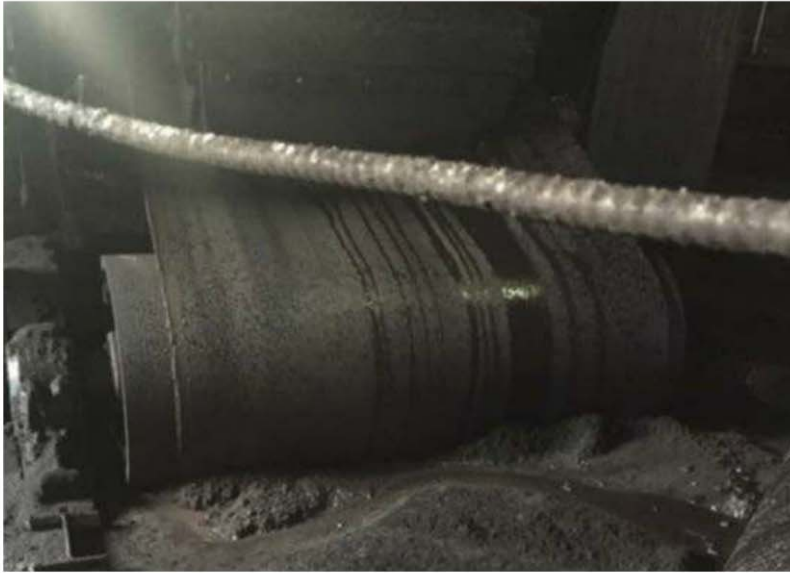
Figure 3. The tail pulley is buried in coal.

A worker cleaning up spillage around a tail pulley buried in fugitive material (Figure 3) needs to be aware of the stored energy in these systems. There have been recorded incidents in which a worker has suffered crushing injuries and even been killed when tension is relieved as the tail pulley breaks free after fugitive material locking it in place is removed during cleanup operations. Many belt manufacturers

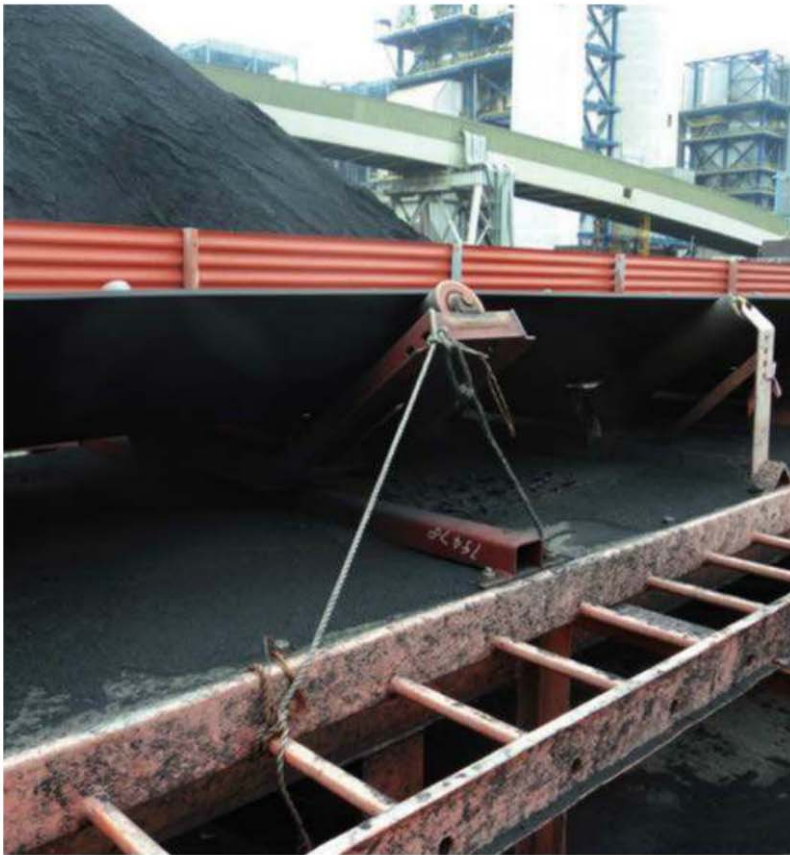
Figure 4. Ordinary training idler tied off with a rope causing material buildup on the support frame work and belt edge damage from friction and pressure.

ordinary training idlers tied off with a rope to ensure that the belt receives maximum influence (Figure 4). This is a tremendous safety hazard for employees working near the conveyor. This old belt training technology can frequently result in belt edge damage from friction and pressure, as well as delamination of the belt carcass, which is the tension member responsible for carrying the load.

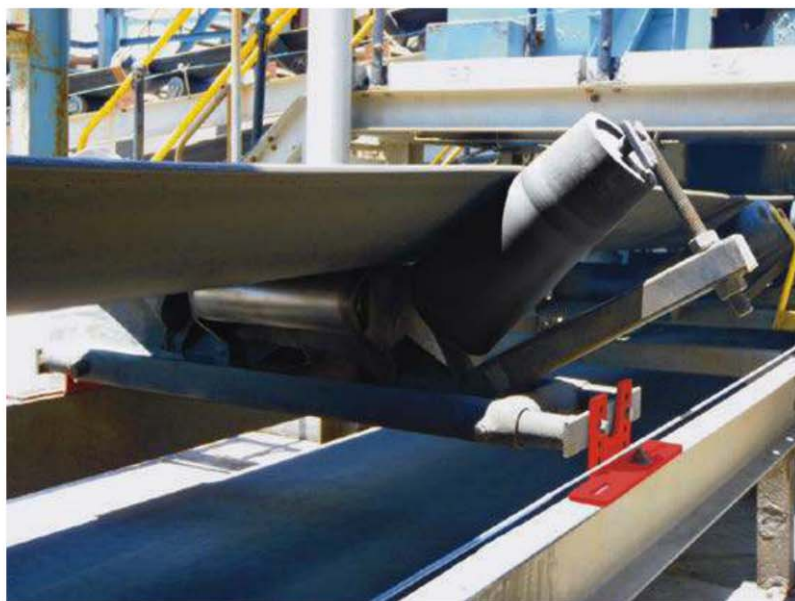
Figure 5. Tru-Trainer® tapered troughing idler reacts to keep the belt centred with no belt edge contact to create friction.

There is no support mechanism required under the tracking device for material to build up on, as is common with all other styles of training idlers available. The safety by design with the ASGCO Tru-Trainer relies on a self-activating internal pivot that does not need side guide rollers to influence the belt

Another fugitive material issue in coal handling facilities is the fact that some coals can be plagued by combustible dust issues. Heat from friction can be a source of concern. The ASGCO Tru-Trainer has no belt edge contact to create friction. The desire to keep the system running at maximum production output can be achieved safely and with a lower total cost of ownership. The Tru-Trainer conveyor belt tracking idler employs a quick action pivot design, which is non-damaging to the belt and reacts immediately, if the conveyor belt begins to drift off centre, eliminating the need for side guides or ropes. It is always reacting to keep the belt centred. Its stainless steel internal pivot that is perpendicular to the plane of the belt, its rubber covered shell and tapered ends (Figure 5) helps actuate the trainer belt immediately as the belt moves off centre. It does not wait, like conventional trainers, for the conveyor belt to walk over to 90° sensor rollers and then have the belt react.

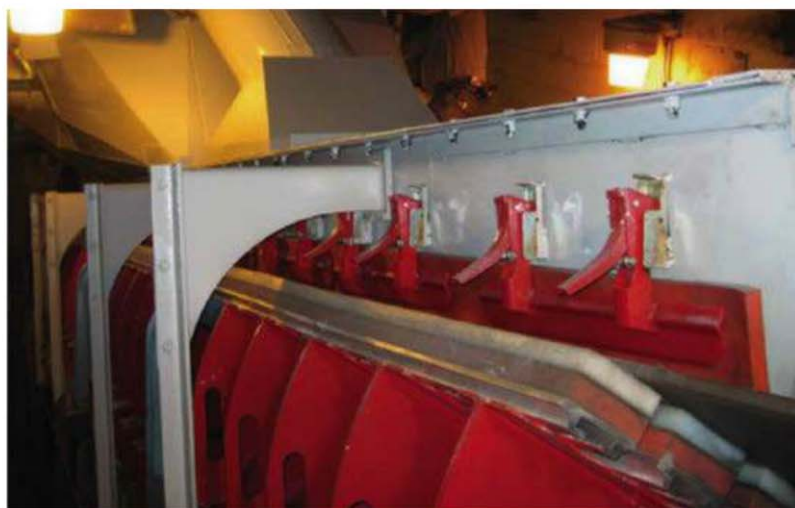
Figure 6. Modular style Impact Cradle Beds consist of a heavy frame with removable (slide-in or slide-out) sides for ease of installation and maintenance.

Ergonomics contributes to 15% of work related injuries in the form of sprains and twists. ASGCO's modular Impact Cradle Beds (Figure 6) slide out from the side in segments, making them easier to handle and requiring both less time and fewer people to service. Since the average cost to an employer for these type of injuries is US\$13 000 according to government statistics, safety pays for the company, as well as the maintenance worker who expects to go home and enjoy his family. <sup>W</sup>
