THE TALE OF TWO TRANSFERERS

Phil Wowak, ASGCO, USA, discusses two case studies that look at improving engineering transfer points – the first involving multiple load points and the second concerning a complex stacker reclaim system with a reversing belt.

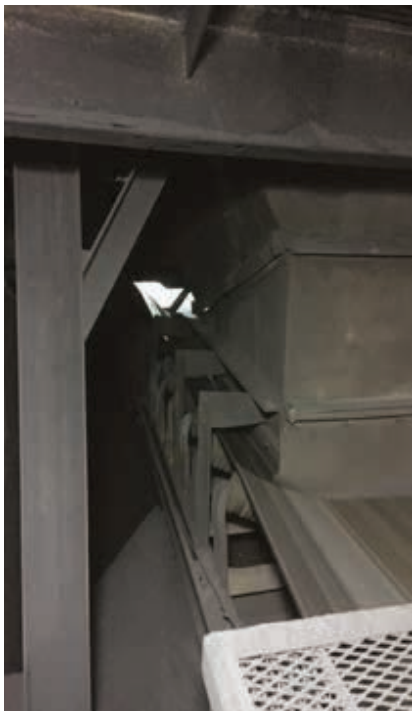
Figure 1. Primary load point.

adjust and replace the skirting seals due to flexing of the belt in this short transition. The belt was only supported with these 20° idlers on 24 in. centres under the loading point. Internal wear resistant skirt seal liners were not used in the load zone, which also contributed to the excessive leakage and the need for constant vacuum cleaning of the pit area under the railcar dumpers (Figure 1).

Due to structural and elevation issues with the original design of the primary load zone, 20° troughing idlers had to be installed under the load chute impact area. The belt was then immediately transitioned to 35° troughing idler in less than 4 ft, while still in the skirt seal area. The width of the skirting load area also exceeded the recommended two thirds of the belt width. This type of idler transition is not recommended with such a short distance in the skirted loading area. This created a material leakage and dusting issue, as well as the need to

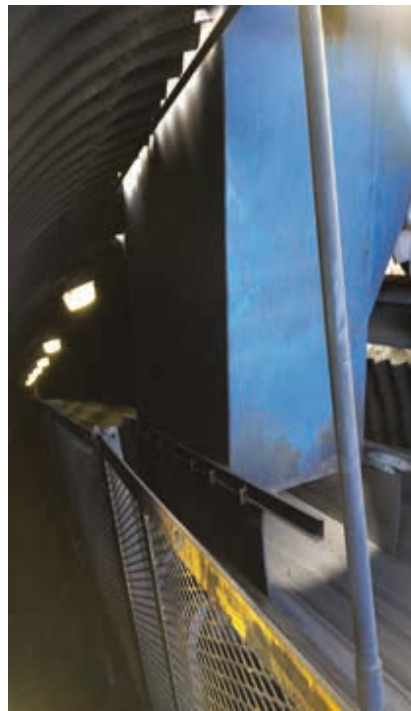
Figure 2. Secondary load point.

The secondary load point that was added to the system in order to blend product did not have a continuous skirt seal area from the primary loading point up stream, which caused the material on the belt to be ploughed off onto the ground when surge loading or belt mistracking occurred. The load profile on the belt was too wide due to the 20° idlers and loading chute that exceeded the maximum width at the first zone. These issues also created the need for weekly coal spillage clean up using costly vacuum trucks, as well as excessive air born dusting (Figure 2).

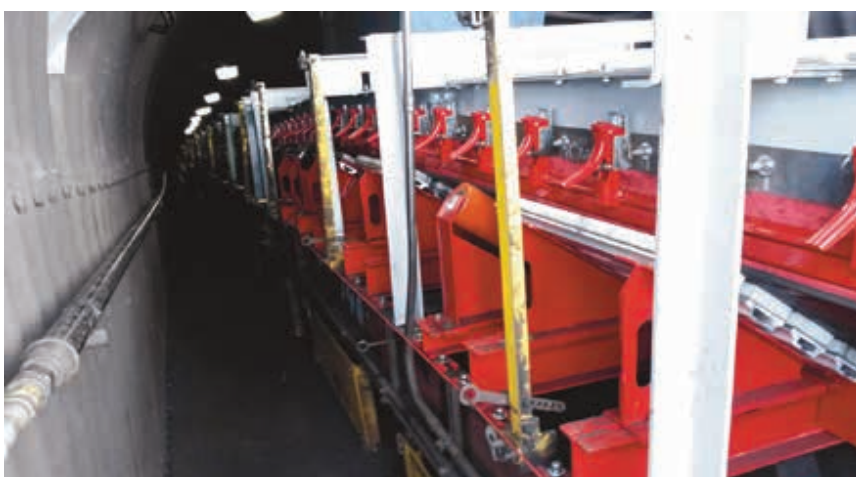
Figure 3. Secondary load point and full length skirt tunnel.

A skirting tunnel section that incorporated the externally mounted inner skirting wear liner was installed the full length between the first and second load zones. In addition, the second load point was retrofitted with modular impact load support beds and an extended exit skirting tunnel with several dust curtains throughout the full length. The externally mounted

internal wear liner protects the skirt seals and allows for easy maintenance and replacement from the catwalk, eliminating the need to remove the skirting covers or having to work from inside of the chute (Figure 3).

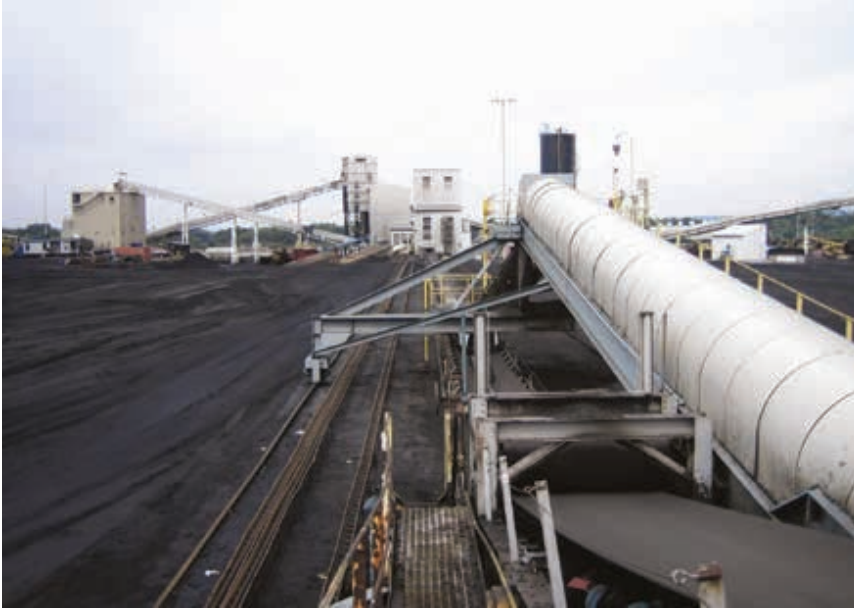
Figure 4. Reclaim conveyor.

The second case study involves a stacker reclaimer conveyor system at a major northeastern coal-fired power plant. It proved to be more complicated and required a more in-depth solution that included a 3-DEM material flow analysis to solve some of the problems. The chute was designed to transfer up to 1400 tph of bituminous coal from the 42 in. reclaim conveyor to the 60 in. reversing yard belt. The reclaim conveyor speed is 700 ft/min. with a capacity of 1400 tph during reclaim operation. The 60 in. reversing yard conveyor speed is 850 ft/min. and has a capacity of 3000 tph in stack out mode (Figure 4).

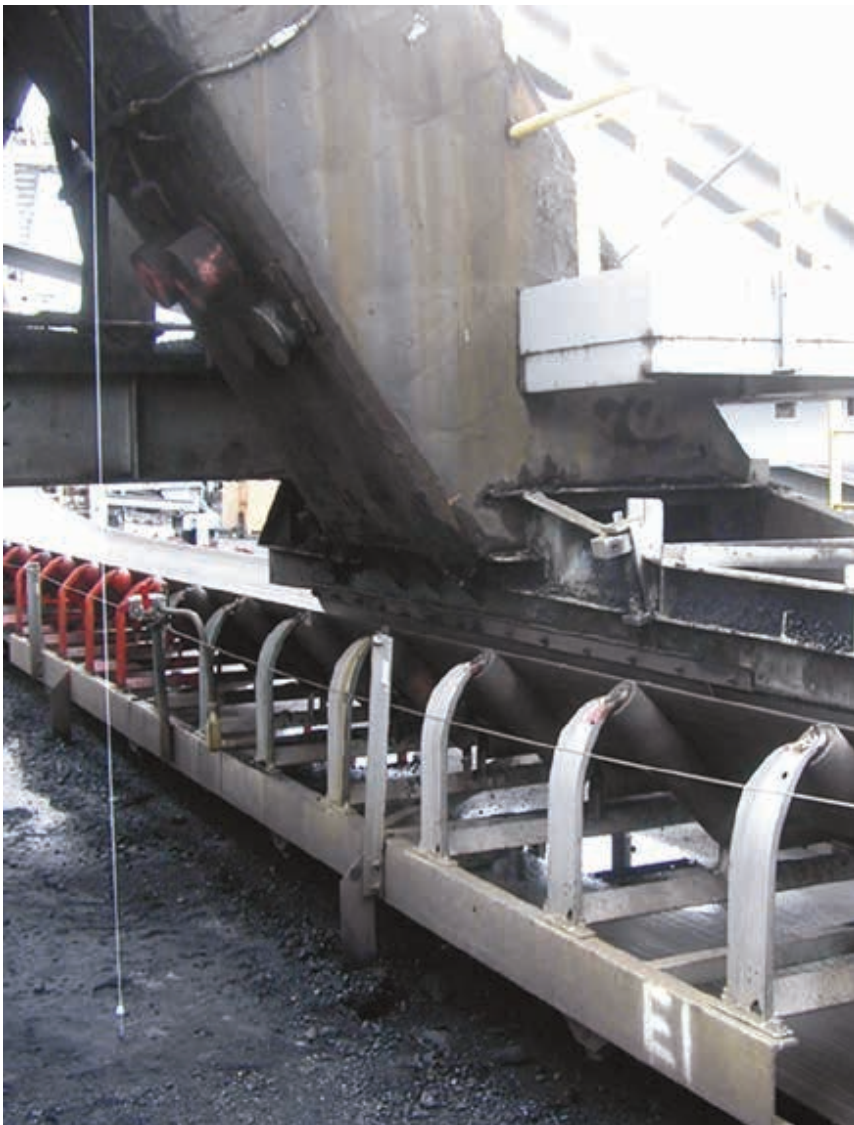
Figure 5. Off-centre loading onto yard belt.

This transfer point was a major problem area for the coal yard operators. While in reclaiming operation, the chute would build up and plug when running wet coal or during freezing conditions. Chute heaters, vibrators and internal baffles were added but the problem still remained. Due to the angle of discharge onto the 60 in. receiving conveyor, off-centre loading caused serious belt mistracking and constant spillage and clean up issues. Electric heat tracing of the chute was installed to help prevent freeze-up during winter operation, as well as several vibrators to try and keep the coal flowing. With all of these installed, they still experienced major coal buildup and plugging of the chute, which caused delays in sending coal to the power plant (Figure 5).

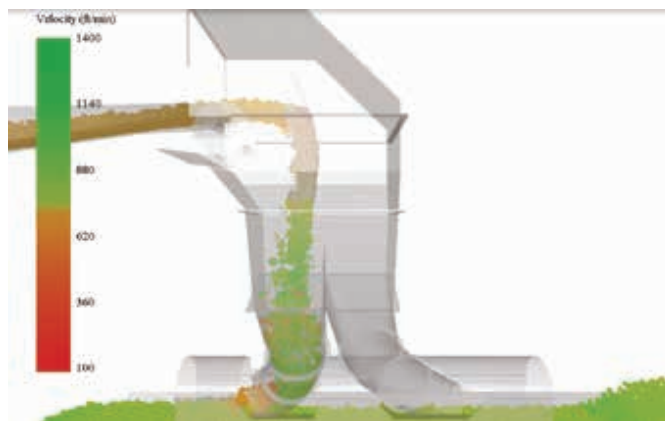
How do you change the direction of the coal stream inside a transfer chute without using a diverter gate? The design engineers came up with a solution that used a movable deflector hood in the head discharge area to divert the coal stream into one of two outlet chutes. This design eliminated all of the buildup and freezing issues that occur when using an in line, swing blade diverter gate (Figure 6 and 7).

Figure 6. Hood in reclaim mode.

Figure 7. Hood in stack out mode.

A new transfer chute was modelled and designed to allow the coal to be loaded onto the receiving belt, moving in the same direction, speed and in the centre. The new design also eliminated corner buildup and reduced wear due to impact and misdirection. The adjustable upper deflection hood was power actuated to prevent a chute overload when the upset condition (i.e. reclaiming while stacking out) was occurring. The hood was automatically positioned in the head chute to direct the coal during either stack out or reclaim. This prevents a chute overload during the upset condition.

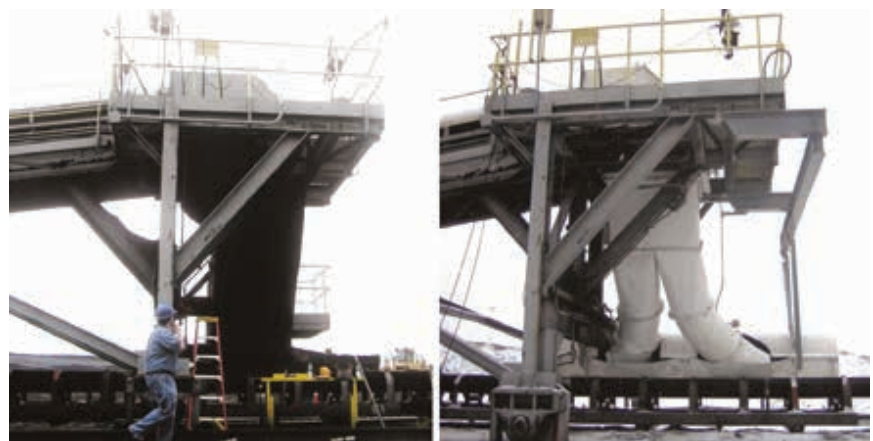
Figure 8. Before (left) and after (right) installation of the new transfer chute with movable deflector gate in the head discharge area and two outlet chutes.

The new transfer chute now operates without buildup and the coal flow is centre loaded onto the 60 in.

receiving belt at the same speed and direction. This reduces wear and belt mistracking, as well as fugitive dusting and spillage clean-up. There is no longer a need for chute vibrators and the plant has still not re-installed the heaters.
