ASGCO[®]'s Washboxes Solve Copper Mine's SAG Mill Plant Feed Conveyor Belt Carryback Challenges and Optimizes Water Consumption Usage

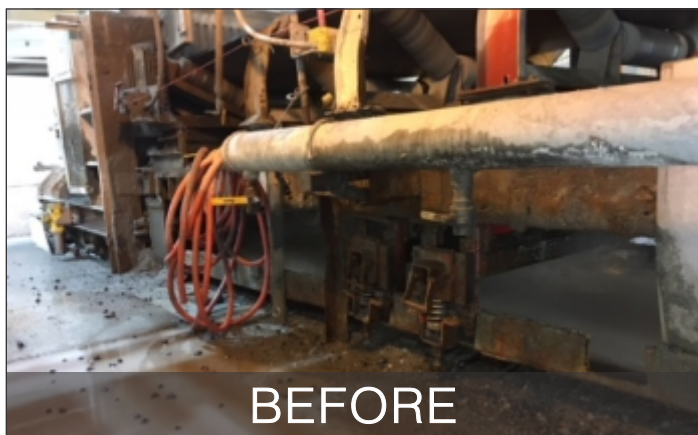
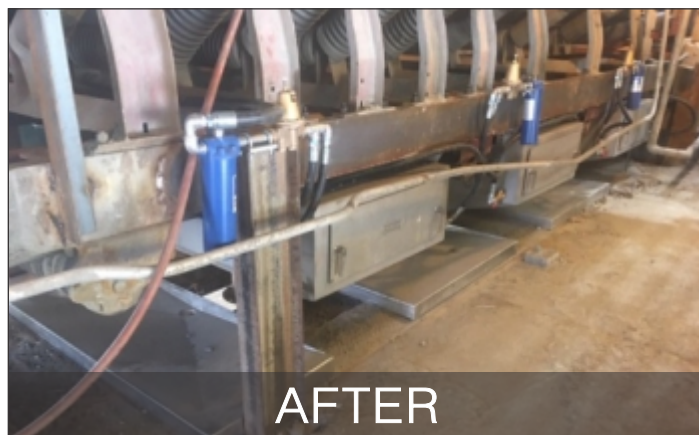
The copper mine's concentrator was utilizing a problematic wash bay on their SAG Mill Feed Belt to contain carryback and to assist in the handling of carryback/slurry removal from the tertiary cleaners. The wash bay's design consisted of a 40' long metal installed underneath the conveyor belt with a series of water jets that sprayed the dirty side of the belt and slurried the carryback into the head pulley's chute. The wash bay had challenges in containing the water and struggled with build-up. Supply water was acidic rotting the conveyor belt structure and flooring.

ASGCO[®]'s representatives performed a complete conveyor survey and had the mine personnel describe the issues. After thorough analysis, ASGCO[®] recommended removing the wash bay and installing (3) three 54" stainless steel ASGCO[®] Wash-boxes[™] to maintain effective cleaning pressure while containing the wash waste fluid. Additionally, ASGCO[®] installed (3) three stainless steel Drip Pans.

Following ASGCO[®]'s improvements, there has been a significant decrease of water consumption in the copper mine. Along with this, the acidic water that damaged the belt structure and flooring has been mostly eliminated and the challenges of trough-slurry management have been resolved. As a result, water is being used more efficiently and production in the copper mine has increased.
