ASGCO[®] Solves Material Spillage at a Large Southeast Pellet Mill

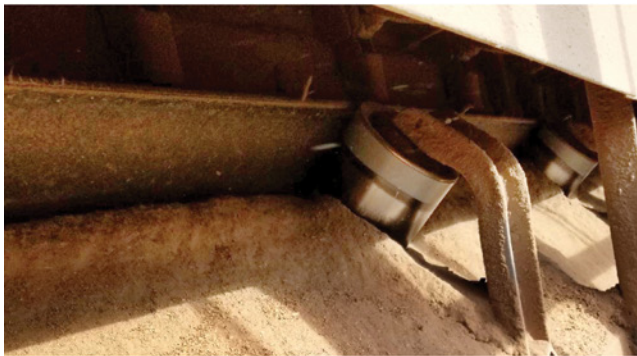
The customer had a large/reoccurring spill problem on top of their 140' Silos. A drag chain conveyor fed a 30' long, 24" wide reversing conveyor that filled their two Silos with wood pellets for their Rail Loadout. Originally the idlers were spaced out 4ft apart and did not offer proper support for the belting or skirting. This allowed fugitive material to escape the skirting, causing excess spillage, leading to poor housekeeping and dangerous conditions.

BEFORE WITH STANDARD PARTS.

Solutions: We installed a total of 20' of ASGCO[®] Slide-N-Roll Beds and 6 Slide-Lers. We configured 10' of Slide-N-Roll Beds directly under the load point in the center of the conveyor. Next, we used an ASGCO[®] Slide-Ler and a 5' Slide-N-Roll Bed on each end of the conveyor, followed by transitional Slide-Lers on each end of the conveyor. Once we had the system properly supported, we recommended ASGCO[®] Multi-Seal Skirting in conjunction with ASGCO Double Handle Skirting Clamps.

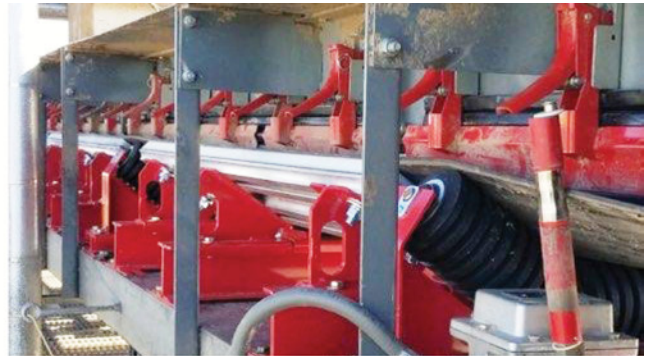
AFTER WITH ASGCO COMPONENTS.

Results: By adding the modular ASGCO[®] Slide-N-Roll[™] Beds and Slide-Lers[™] now the conveyor belt was properly supported, creating a consistent plane for the ASGCO[®] Multi-Seal[™] Skirting to properly seal the material being conveyed. This reduced the spillage clean up time from 20 hours to 4 hours per month.
