PROVIDING THE WORLD'S MATERIAL HANDLING INDUSTRY WITH
EFFICIENT, SAFE AND PRODUCTIVE
COMPLETE CONVEYOR SOLUTIONS

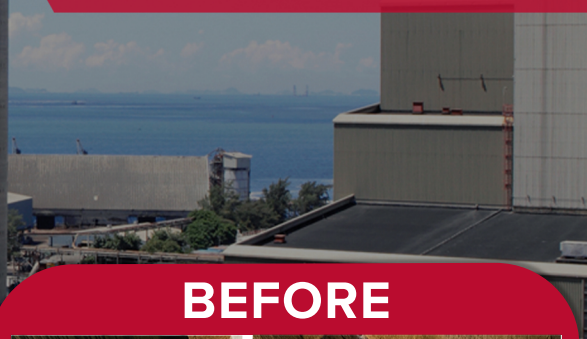
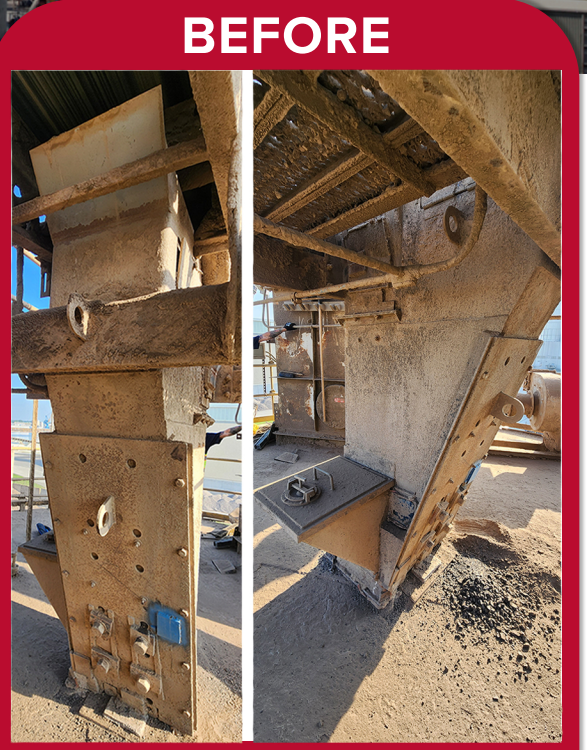
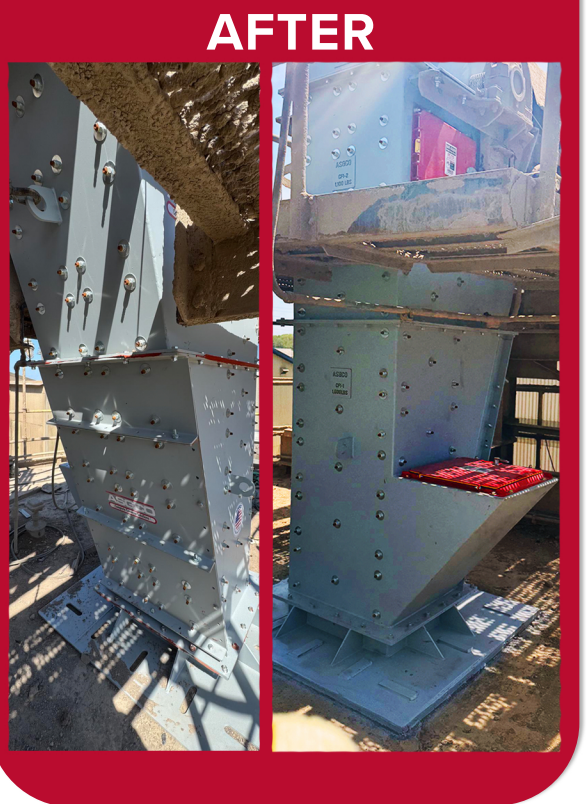
A large cement plant in the Mid-Atlantic was experiencing escalating material spillage issues at the top of a clinker silo. The existing transfer chute had deteriorated significantly over time due to repeated patchwork repairs, leaving it unrepairable and consistently leaking product. An ineffective dribble chute extension failed to capture all discharged material from the belt cleaners, allowing fugitive material to escape and accumulate. This resulted in excessive spillage, poor housekeeping conditions, and increased maintenance demands. Additionally, the chute's inspection doors were difficult to operate, limiting safe and efficient access for maintenance personnel and extending service times.

Our engineers conducted a comprehensive 3D Point Cloud Scan of the chute system to accurately assess the structure and identify key inefficiencies. Using this data, a complete chute redesign was developed to address the root causes of material loss and maintenance challenges. The new chute design was extended to fully encapsulate the belt cleaners, eliminating the need for a dribble chute and removing previous escape points that caused spillage. The system was also engineered with an improved slope angle to prevent material buildup and plugging. To further enhance maintenance efficiency, four strategically positioned inspection doors were integrated into the design, allowing for safer and easier access during routine inspections and service.

Following installation, the improvements were immediate and significant. Material spillage was effectively eliminated, resulting in much cleaner operation and greatly improved housekeeping conditions. The redesigned chute ensured proper material containment and flow, enhancing overall system efficiency. Maintenance access was significantly improved, reducing service time and increasing safety for personnel. The upgraded system transformed a previously problematic transfer point into a reliable, high-performing asset, delivering measurable gains in operational efficiency and long-term performance.
