### ASGCO® TORO™ Secondary Belt Cleaner Installed at This Recycling Facility Solves Major Carry-back Issues.

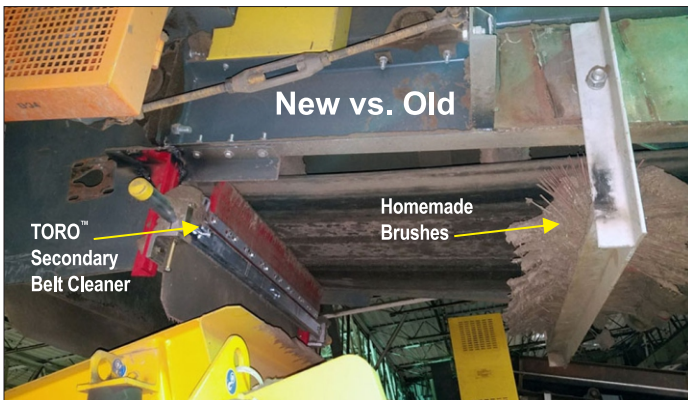
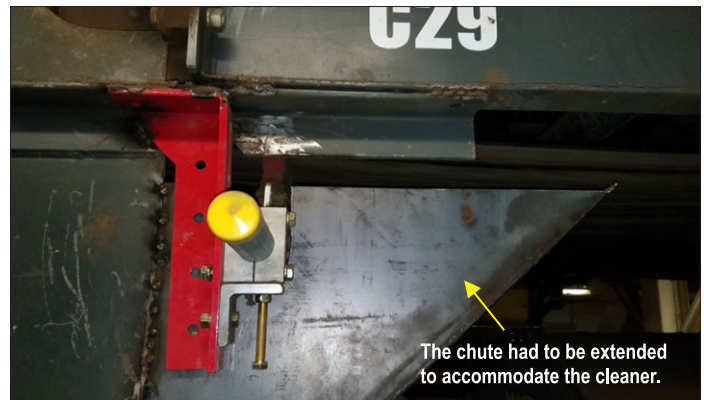
The facility was using homemade brushes but knew they weren't doing the job. Installing ASGCO®'s TORO™ Reversing Belt Cleaner with urethane blades was recommended to provide a secondary belt cleaner that would clean the material off of the belt and keep it contained within the chute, reducing the time spent cleaning up every morning.

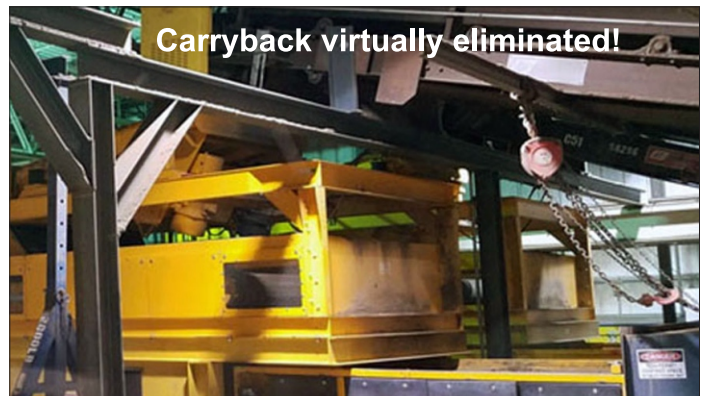
TORO™ Secondary Belt Cleaners exceeded the customers expectations resulting in practically zero cleanup time at the beginning of the shifts. After the two systems were initially bought, they bought four more and will be buying four more to finish out their problem areas inside the plant. Blade wear has also exceeded the customers expectations and they've bought replacement cartridges loaded for quick and easy replacement.
