ASGCO® Low Profile Dual Return Tru-Trainer® System Eliminates Belt Tracking Issues at This Midwestern US Coal Burning Power Plant

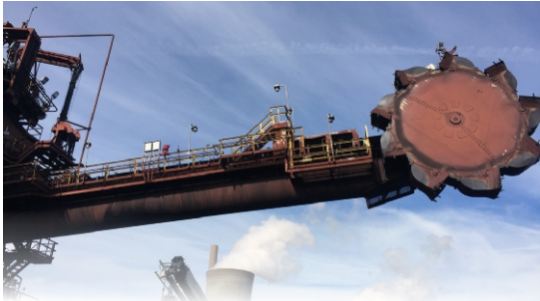
Challenge: For many years this conveyor had a hydraulic three return Idler belt training system that wouldn't properly keep the conveyor belt in line. The plant was facing constantly downtime to repair the hydraulic system. Even when operational, the belt would veer off of center and come into contact with the structural supports, leading to critical damage to the belt and costly material spillage. To further complicate this application, the conveyor also has less than 13" of height to mount any type of return training roller. Options for eliminating the tracking problem were extremely limited by these space restrictions.

On several occasions, the belt became so severely mis-aligned, that it came in contact with the tail section of the support structure, leading to catastrophic damage to the belt, and causing extended downtime for the plant's operations. The problem persisted upon installation of a new belt, and within 12 months, it needed to be completely replaced a second time.

PROBLEM: This conveyor had a failing hydraulic three return Idler belt training system that wouldn't properly keep the conveyor belt in line.

Solution: After ASGCO®'s technicians performed a complete survey of the conveyor system, the problem issues were identified. It was recommended that ASGCO® Tru-Trainer® was to be installed on the return side of the conveyor, 30 feet before the tail pulley. This position would allow the belt to run straight around the tail pulley and also be centered on the conveyor in the load point, reducing spillage and costly material loss. In addition, the rubber disk return idlers were replaced with flat return idlers, eliminating resistance to centering.

Results: After installing two Low Profile Dual Tru-Trainers® about 20' from each stationary pulley, the belt is maintaining center alignment and the problem of belt damage and material spillage has been eliminated. The customer no longer has to shut down operations to repair the belt and the hydraulic system, or to spend valuable hours cleaning up spilled material. Performance has been greatly improved and productivity is at an all time high. This particular customer is very satisfied with the performance of the Tru-Trainers®, and recently placed an order for two additional for a different 60" Stacker Reclaimer Conveyor.

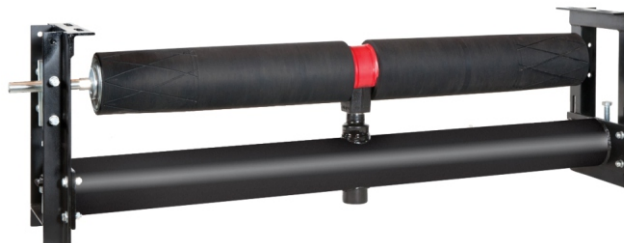
Tru-Trainer® Dual Return Idler

- Patented design does not rely on the conveyor belt to activate
- Designed for high speed /PIW conveyors
- Two separate tapered rolls mounted into the pivot mechanism can be individually replaced
- Enhanced sealing/bearing system for aggressive mining conditions
- Total Satisfaction Guarantee (TSG)
- Reactionary in both wet and dry conditions.

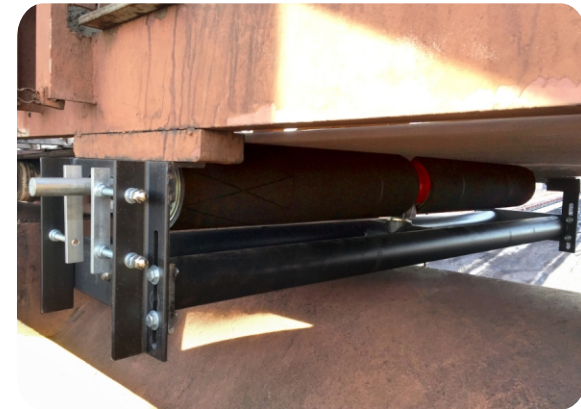
SOLUTION: ASGCO® engineered low profile Dual Return Tru-Trainer® system with a height of only 11.8", installed to continually recenter the belt.
